Chapter IX

The Challenger Accident

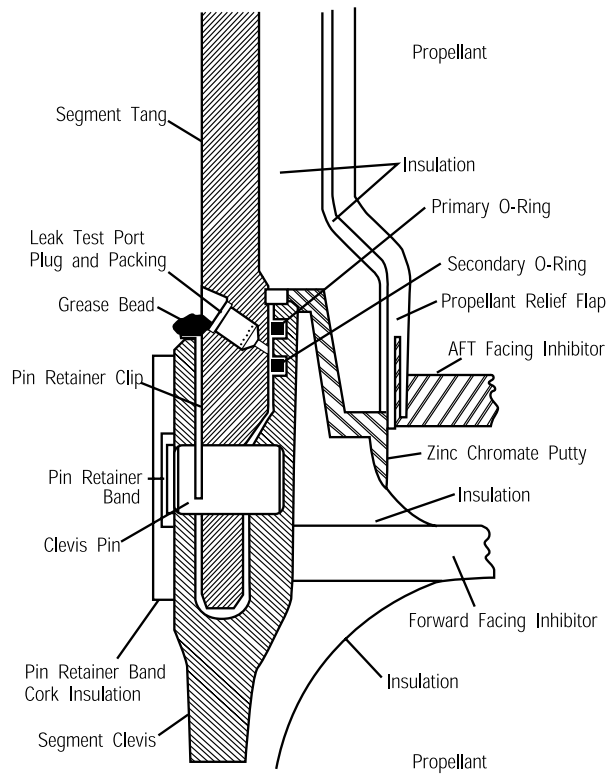
Cross section of SRM field joint.

Solid Rocket Motor cross section shows positions of tang, clevis, and O-rings. Putty lines the joint on the side toward the propellant.

the gap between the O-rings and verify whether the primary O-ring would seal. The leak-check, however, pushed the primary O-ring to the wrong side of its groove.⁹

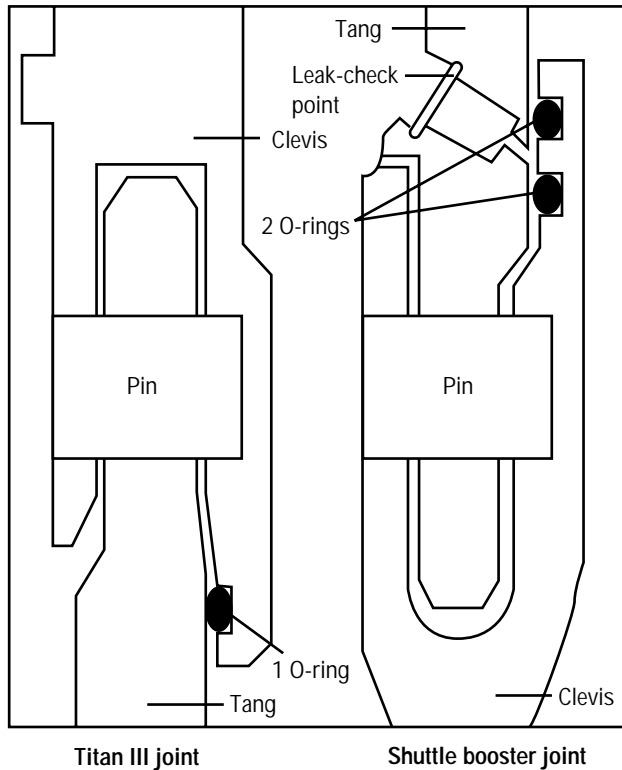
Comparison of Titan III and SRM joints.

The second O-ring forced another departure from the Titan, requiring that the SRM have a longer tang and a deeper clevis. The longer joint of the SRM was more flexible than the Titan, since the combustion pressure in the SRM was one-third higher than the Titan and its case had a greater diameter. Moreover, the SRM clevis pointed up, rather than down like that of the Titan. Finally, to test the seals after connecting the segments, Thiokol engineers added a leak-check port so that compressed air could be forced into

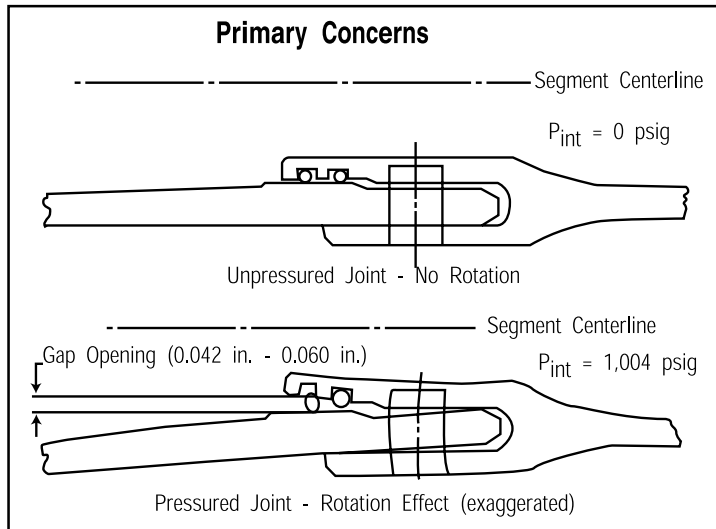
Joint rotation of SRM field joint.

In Weekly Notes, Marshall's SRM project engineers said the burst test revealed "excessive O-ring leakage." Both the primary and secondary O-rings leaked, and disassembly revealed each had pinches and cuts. "The most logical explanation," the MSFC motor engineer observed, "is joint rotation which allowed both O-rings to lose compression."¹³

Joint rotation meant that under pressure the tang and the inner flange of the clevis bent apart and the joint opened (as shown in the joint rotation of the SRM field joint). Rotation occurred because the

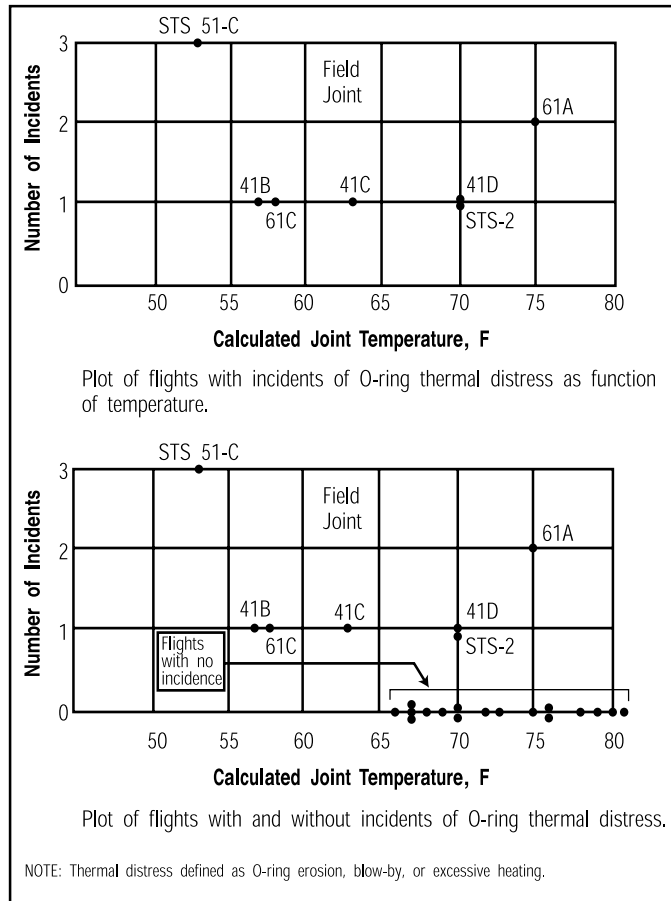
Plots of incidence of O-ring distress as function of temperature.

Concerns arose again in late January 1985 after Mission 51-C. The launch was the Shuttle's coldest and O-ring temperature was 53 degrees F. Two primary O-rings in case-to-case field joints had erosion, and primary rings in two field and both nozzle joints had soot blow-by. A form of erosion appeared that differed from previous impingement erosion of a sealed O-ring; blow-by erosion resulted from combustion gases burning an unsealed O-ring and flowing beyond it. Not surprisingly a secondary O-ring in a field joint experienced heat damage for the first time.⁵⁵

what we were doing.” No one performed a statistical analysis correlating past O-ring performance with either temperature or leak check pressure.⁶⁰ Lacking such analysis, both Thiokol and Marshall had been correct about 51-C; the contractor engineers had rightly surmised that low temperature increased the probability of erosion, and Center managers had rightly questioned Thiokol’s demonstration of the correlation.
