Chapter IX

The Challenger Accident

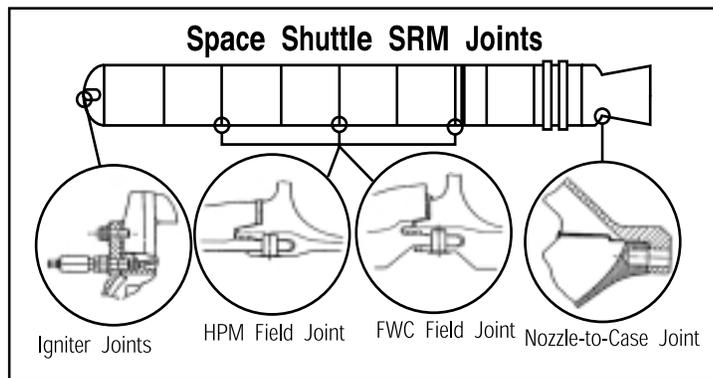
Space Shuttle solid rocket motor joints.

ded into several segments (as shown in illustration of Shuttle SRM joints). This meant that the design required joints and seals to prevent leaks of the high-temperature, high-pressure propulsion gases. Thiokol's engineers used the Titan III-C rocket, considered state of the art for solid motors and very reliable, as their model. The Shuttle motor, however, differed from the Titan because the SRM was larger and intended for refurbishment and reuse. The differences in design showed in the field joints connecting the motor case segments.⁸ The Titan had insulation along the interior wall of the steel case to prevent hot gases from penetrating the joint and damaging its rubber seals (see the SRM field cross section and the comparison illustration if Titan III and SRM joints); the SRM used an asbestos-filled putty. The segments had upper and lower parts; Thiokol engineers expected that motor pressure would push together the "tang" (the tongue on the rim of the upper segment) and the inner flange of "clevis" (the groove on the rim of the lower segment) and facilitate sealing. Motor pressure would also push the primary O-ring, a quarter-inch diameter rubber gasket, against the steel case and seal the joint. Thiokol sought redundancy by placing a second O-ring behind the primary O-ring.

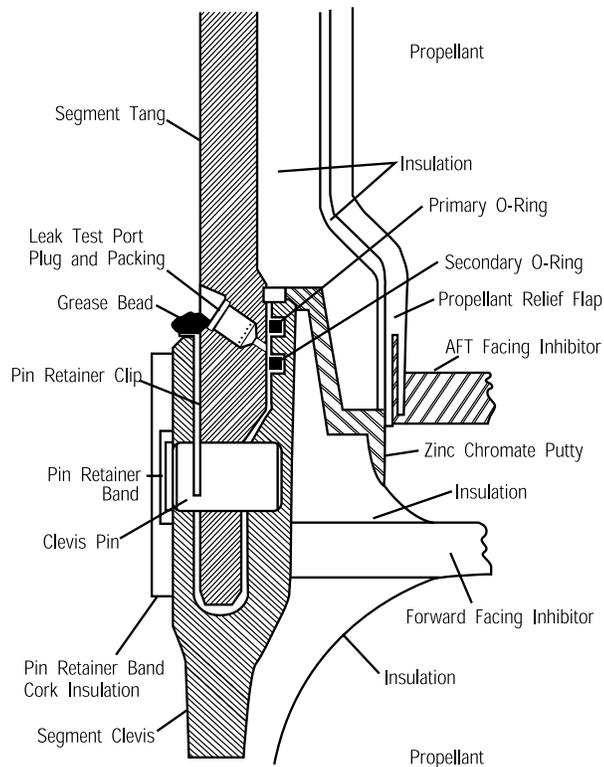
Cross section of SRM field joint.

Solid Rocket Motor cross section shows positions of tang, clevis, and O-rings. Putty lines the joint on the side toward the propellant.

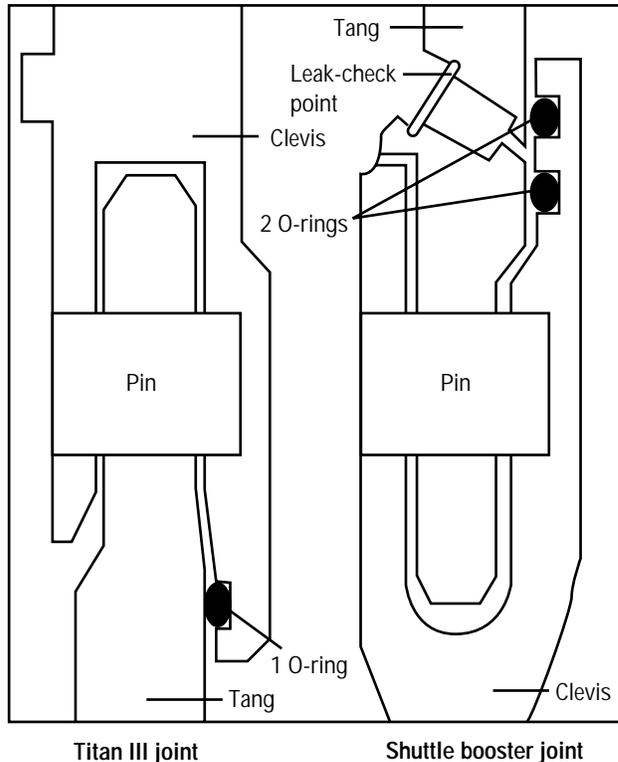
The second O-ring forced another departure from the Titan, requiring that the SRM have a longer tang and a deeper clevis. The longer joint of the SRM was more flexible than the Titan, since the combustion pressure in the SRM was one-third higher than the Titan and its case had a greater diameter. Moreover, the SRM clevis pointed up, rather than down like that of the Titan. Finally, to test the seals after connecting the segments, Thiokol engineers added a leak-check port so that compressed air could be forced into

Comparison of Titan III and SRM joints.

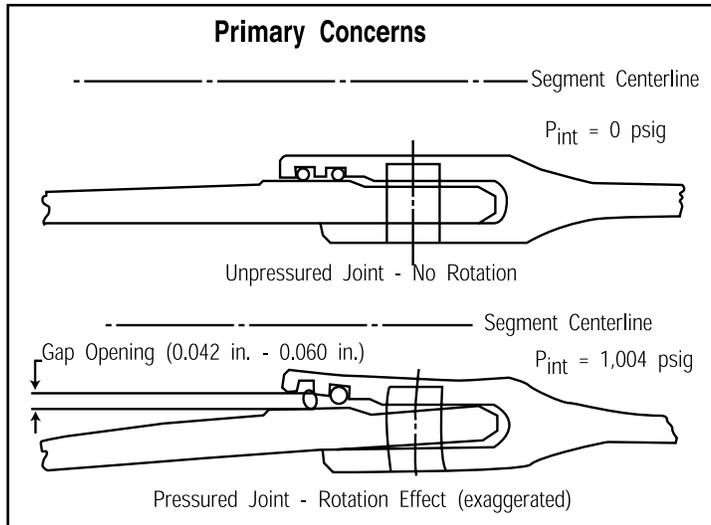
Joint rotation of SRM field joint.

In Weekly Notes, Marshall's SRM project engineers said the burst test revealed "excessive O-ring leakage." Both the primary and secondary O-rings leaked, and disassembly revealed each had pinches and cuts. "The most logical explanation," the MSFC motor engineer observed, "is joint rotation which allowed both O-rings to lose compression."¹³

Joint rotation meant that under pressure the tang and the inner flange of the clevis bent apart and the joint opened (as shown in the joint rotation of the SRM field joint). Rotation occurred because the

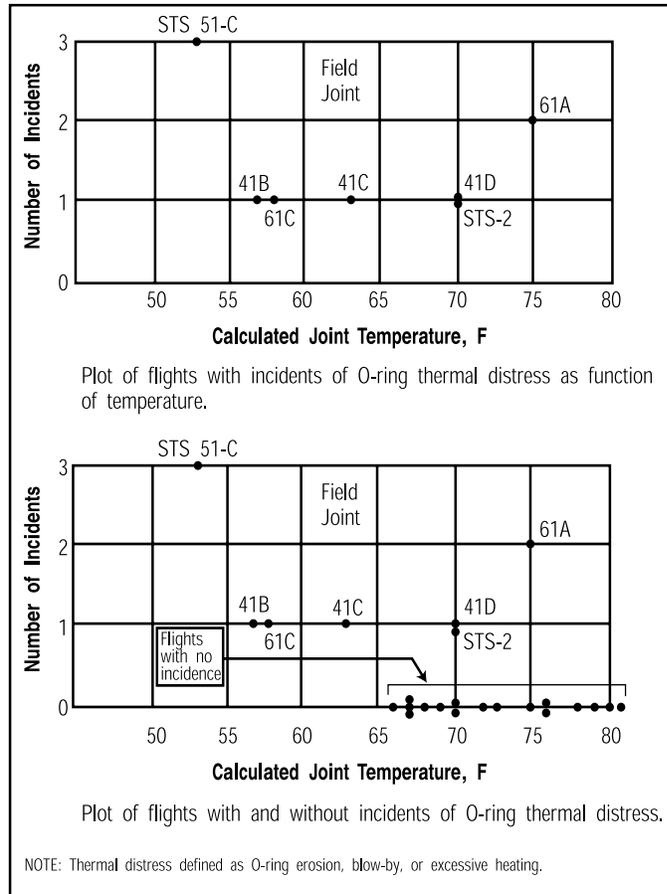
what we were doing.” No one performed a statistical analysis correlating past O-ring performance with either temperature or leak check pressure.⁶⁰ Lacking such analysis, both Thiokol and Marshall had been correct about 51-C; the contractor engineers had rightly surmised that low temperature increased the probability of erosion, and Center managers had rightly questioned Thiokol’s demonstration of the correlation.

Plots of incidence of O-ring distress as function of temperature.
