Chapter IX

The Challenger Accident

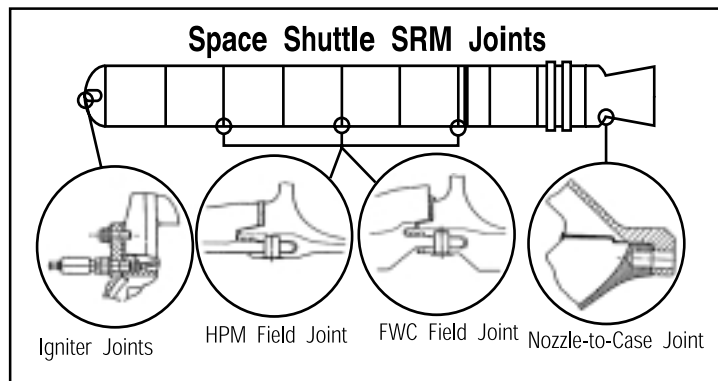
Space Shuttle solid rocket motor joints.

into several segments (as shown in illustration of Shuttle SRM joints). This meant that the design required joints and seals to prevent leaks of the high-temperature, high-pressure propulsion gases. Thiokol's engineers used the Titan III-C rocket, considered state of the art for solid motors and very reliable, as their model. The Shuttle motor, however, differed from the Titan because the SRM was larger and intended for refurbishment and reuse. The differences in design showed in the field joints connecting the motor case segments.⁸ The Titan had insulation along the interior wall of the steel case to prevent hot gases from penetrating the joint and damaging its rubber seals (see the SRM field cross section and the comparison illustration of Titan III and SRM joints); the SRM used an asbestos-filled putty. The segments had upper and lower parts; Thiokol engineers expected that motor pressure would push together the "tang" (the tongue on the rim of the upper segment) and the inner flange of "clevis" (the groove on the rim of the lower segment) and facilitate sealing. Motor pressure would also push the primary O-ring, a quarter-inch diameter rubber gasket, against the steel case and seal the joint. Thiokol sought redundancy by placing a second O-ring behind the primary O-ring.
